NAPA RIVER SALT MARSH AND NAPA PLANT SITE RESTORATION PROJECTS BIENNIAL REPORT PRELIMINARY SUMMARY

Karen Taylor, Environmental Scientist
Napa-Sonoma Marshes Wildlife Area

NSMRG MEETING

December 7, 2017

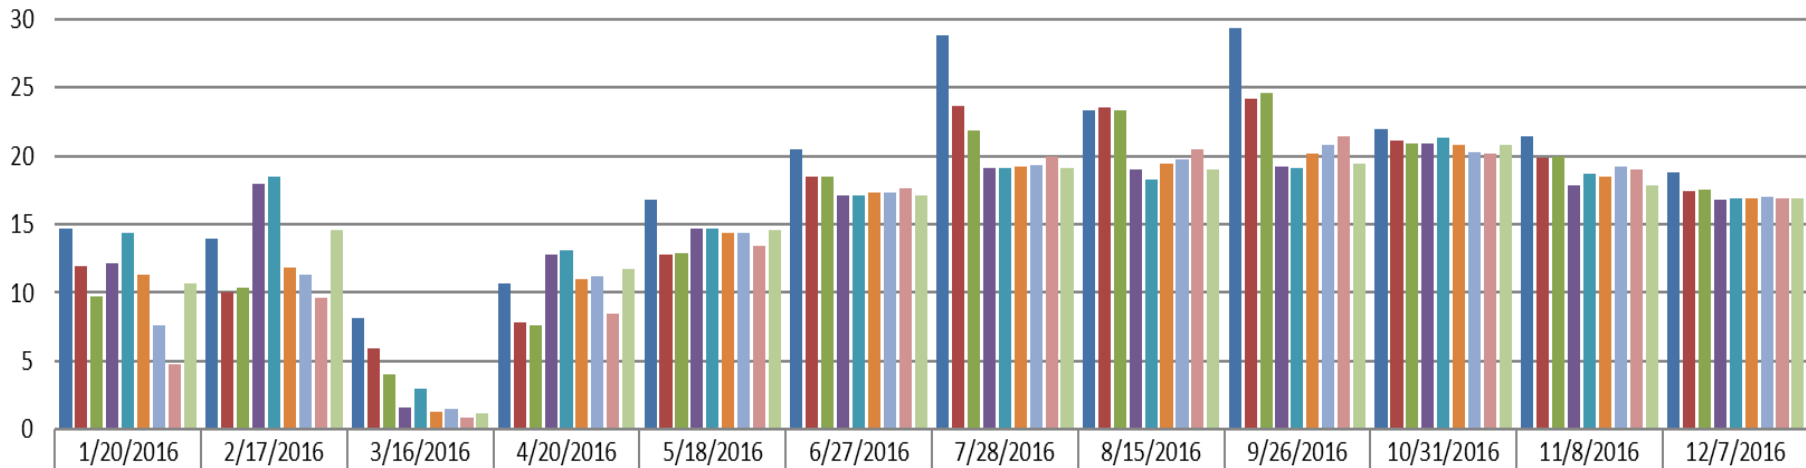
2016 Salinity (ppt) Ponds 1-5 with Napa River

1/20/2016	2/17/2016	3/16/2016	4/20/2016	5/18/2016	6/27/2016	7/28/2016	8/15/2016	9/26/2016	10/31/2016	11/8/2016	12/7/2016
1	14.63	13.99	8.12	10.62	16.80	20.47	28.78	23.28	29.33	21.90	21.45	18.82
1A	11.91	10.07	5.88	7.85	12.75	18.47	23.64	23.52	24.13	21.07	19.89	17.47
2	9.76	10.33	4.03	7.65	12.87	18.43	21.80	23.27	24.54	20.90	19.92	17.56
3A	12.17	17.98	1.62	12.76	14.72	17.11	19.06	19.05	19.21	20.89	17.79	16.82
3B	14.34	18.49	3.01	13.14	14.69	17.06	19.14	18.22	19.15	21.27	18.73	16.87
4A	11.35	11.82	1.26	10.95	14.31	17.28	19.26	19.37	20.14	20.74	18.46	16.88
4B	7.64	11.27	1.51	11.20	14.36	17.35	19.32	19.70	20.74	20.30	19.16	16.99
5A	4.82	9.6	0.87	8.45	13.41	17.65	20.00	20.43	21.39	20.11	18.99	16.89
NR CL	10.70	14.6	1.14	11.76	14.52	17.11	19.06	18.98	19.46	20.80	17.79	16.93

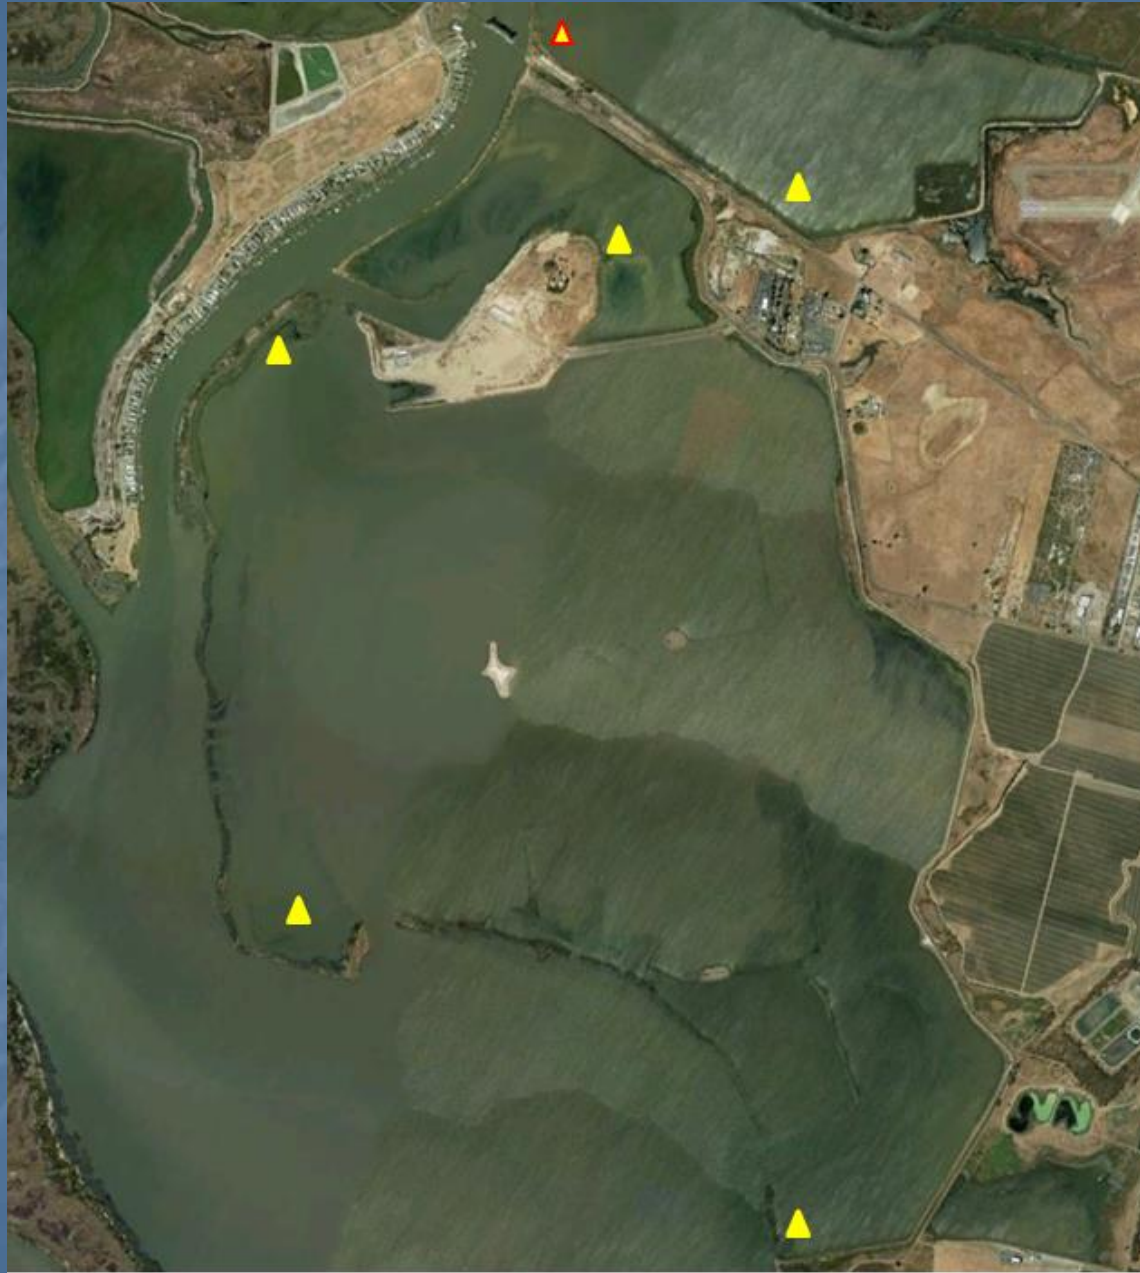
Napa Plant Site Restoration Sedimentation Plate Location Map

Napa Plant Site Restoration Sediment Plate Locations

▲ -Sedimentation Plate

▲ -Missing Sedimentation Plate

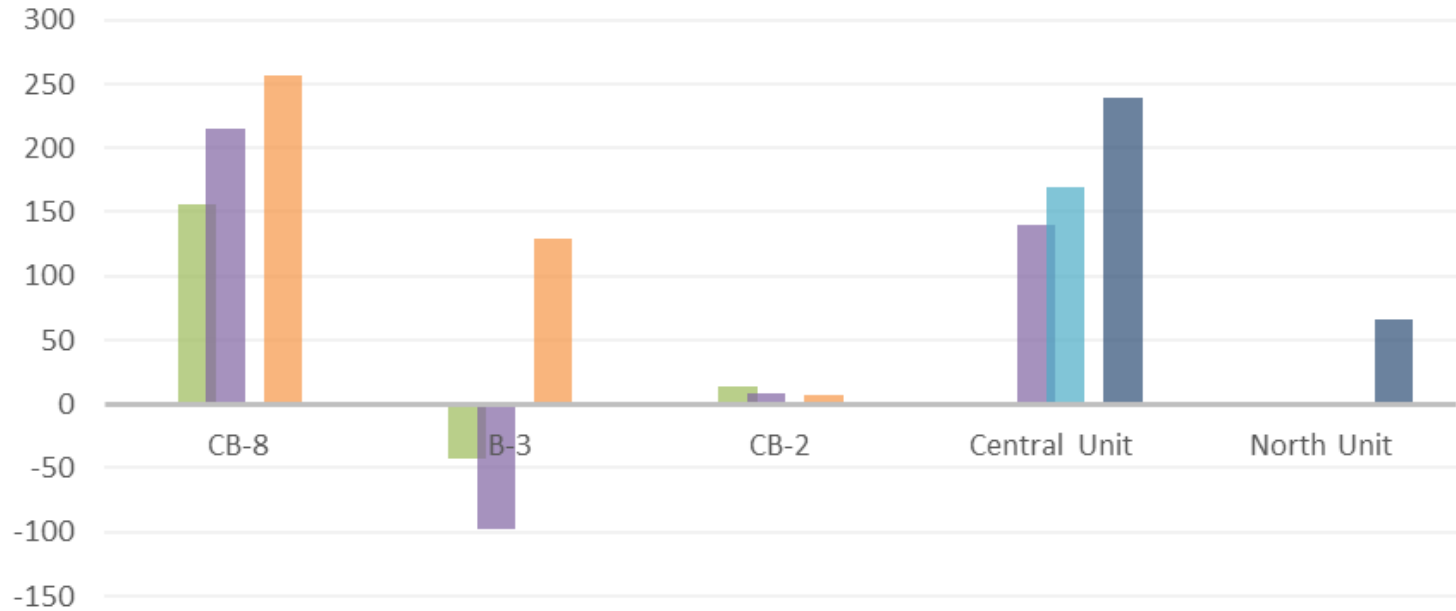
NPS Sedimentation Plates 2009-2017

- 2009 Placement Measurement (Base)(mm)
- 2010 Placement Measurement (Base)(mm)
- 2012 Measurement (mm)
- 2013 Measurement (mm)
- 2014 Measurement (mm)
- 2015 Measurement (mm)
- 2016 Measurement (mm)
- 2017 Measurement (mm)

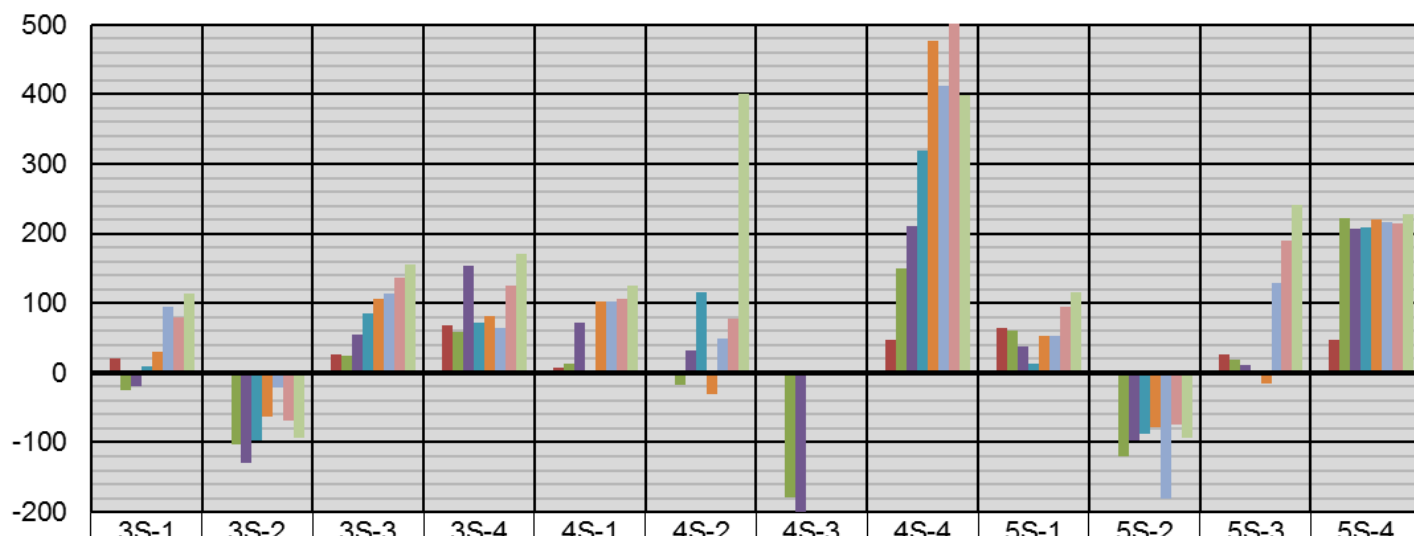
Sedimentation Plates for NSMWA (Ponds 3-5) 2007-2017

Sedimentation Plate (mm)

3S-1	3S-2	3S-3	3S-4	4S-1	4S-2	4S-3	4S-4	5S-1	5S-2	5S-3	5S-4
2007 Measurement (mm) (Base)	0	0	0	0	0	0	0	0	0	0	0	0
2008-2009 Measurement (mm)	21.17	0	26.6	69	7.8	0	0	47.25	65.2	0	26.6	47.25
2011 Measurement (mm)	-25.75	-102.25	24.333	57.833	12.5	-17.25	-178.75	150.167	59.7	-120	18.3	221.8
2012 Measurement (mm)	-19.75	-129.25	55.67	153.33	72.17	32.17	-224.00	210.83	37.33	-96.25	11.67	206.83
2013 Measurement (mm)	8.50	-96.5	85	72.33	4.17	116.33	0	318.67	13.83	-87.25	3.50	208.16
2014 Measurement (mm)	31.00	-62.25	107.00	80.67	102.50	-29.75	0	476.67	53.33	-77.75	-16.00	220.83
2015 Measurement (mm)	94.17	-21.00	112.83	64.00	102.5	49.5	0	411.75	53.00	-181.25	128.67	216.17
2016 Measurement (mm)	80.33	-68.00	137.17	124.67	105.5	78.17	0	508.5	95.17	-73.75	190.17	215.17
2017 Measurement (mm)	113.66	-92.75	156.5	170.83	125	400	0	399.33	115.00	-93.75	241.33	227.66

Note: 4S-3 was pulled in 2013 because it had fallen over due to excessive erosion. 4S-2 2017 measurement higher than table. Could not locate.

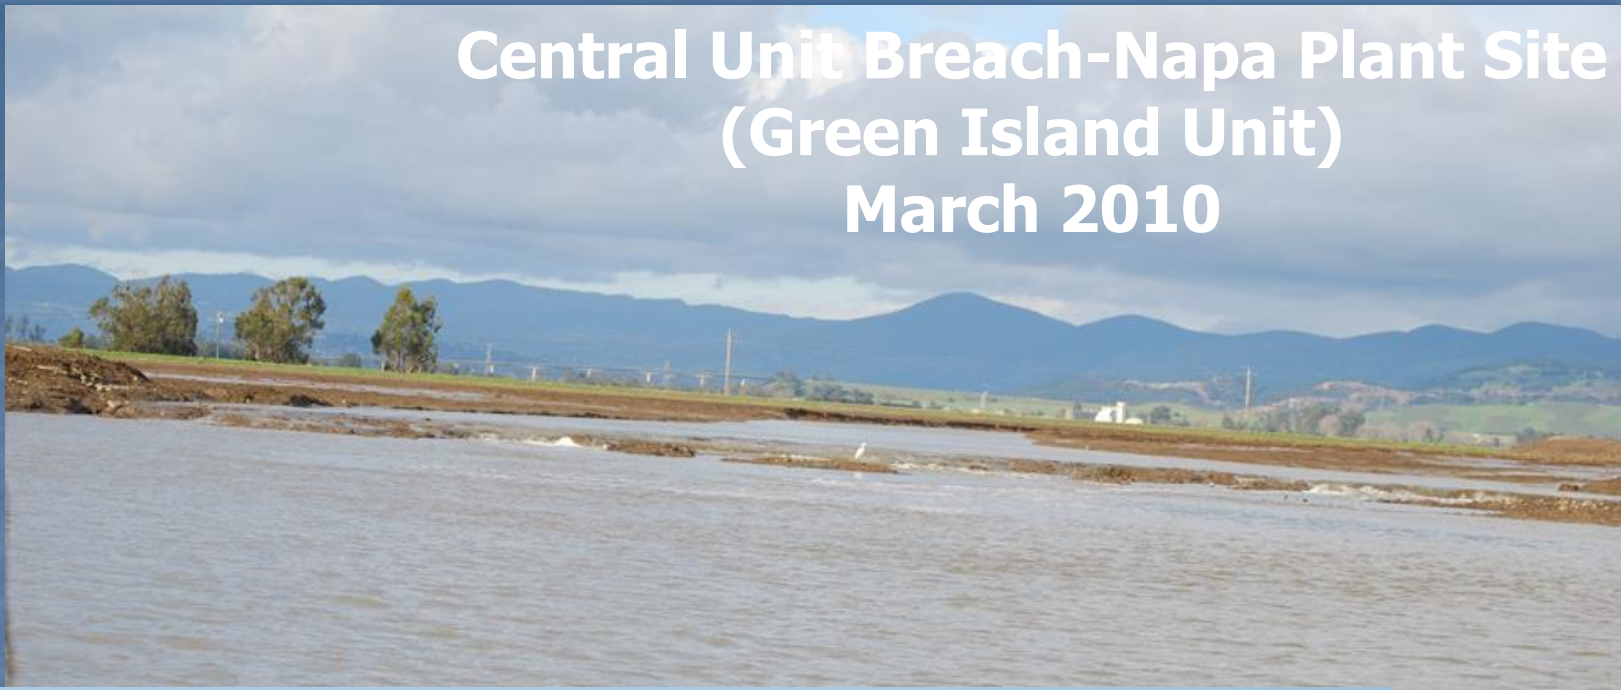
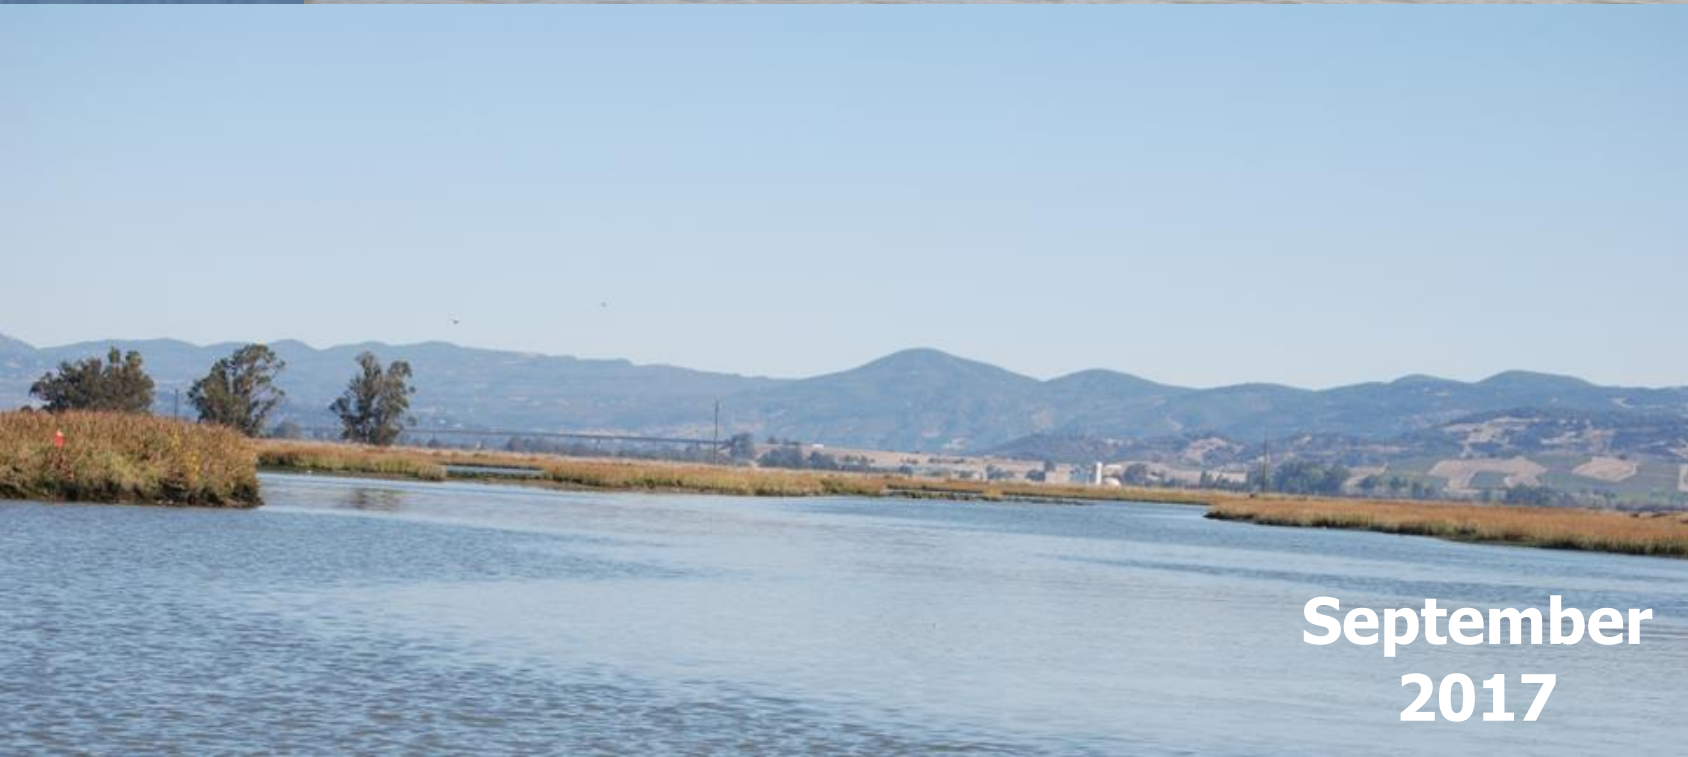
Central Unit Breach-Napa Plant Site (Green Island Unit) March 2010

September
2017

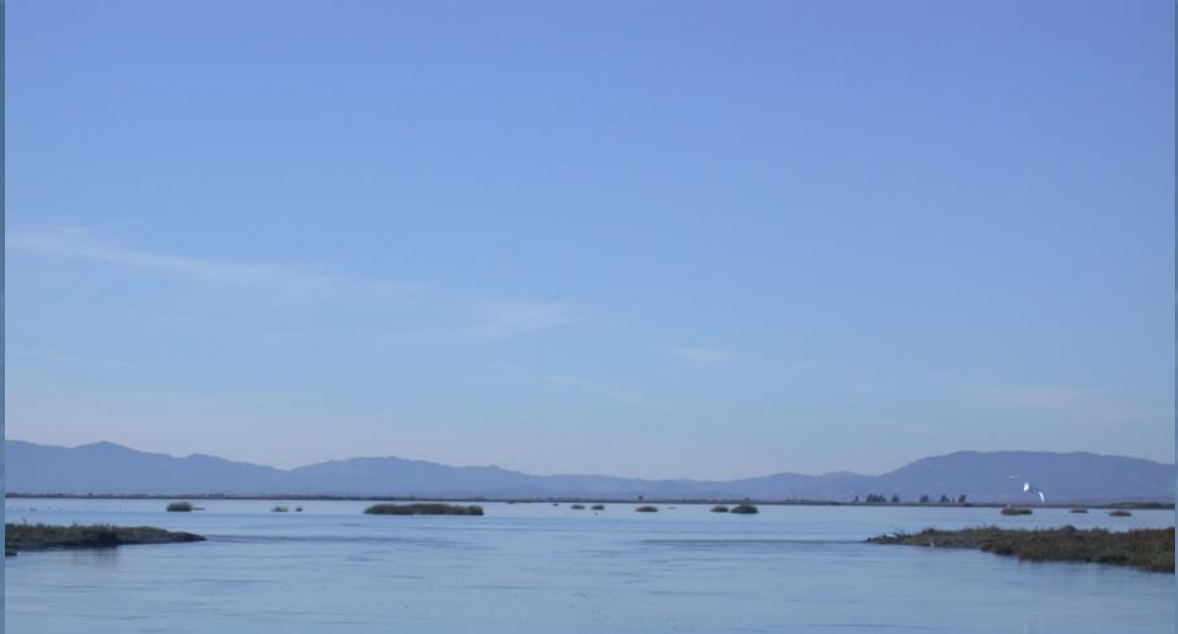
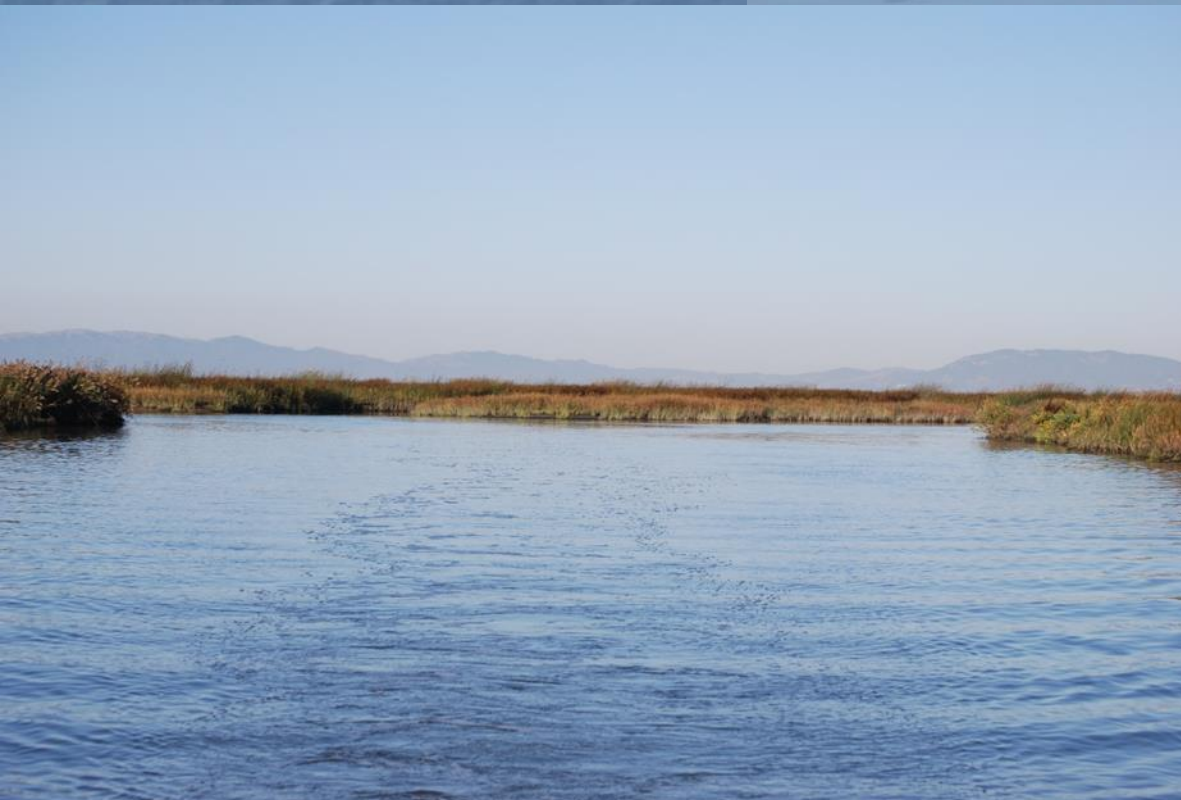
**Pond 3
May 2008**

**September
2017**

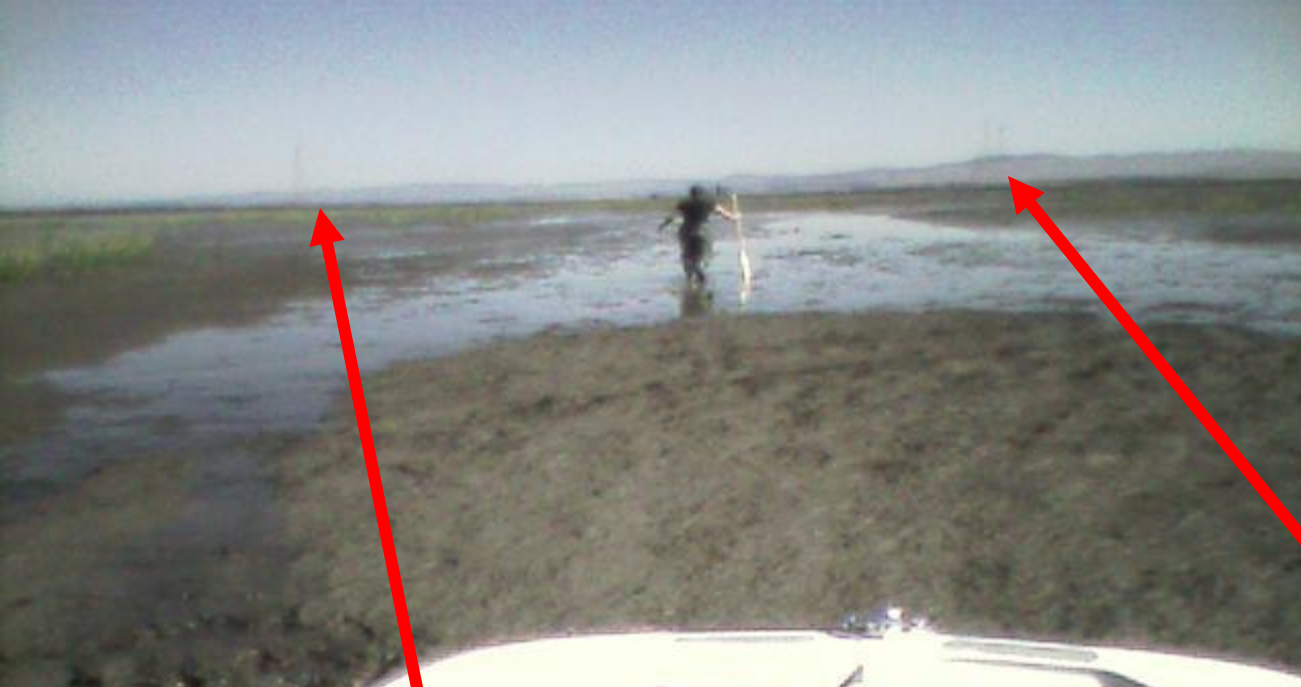
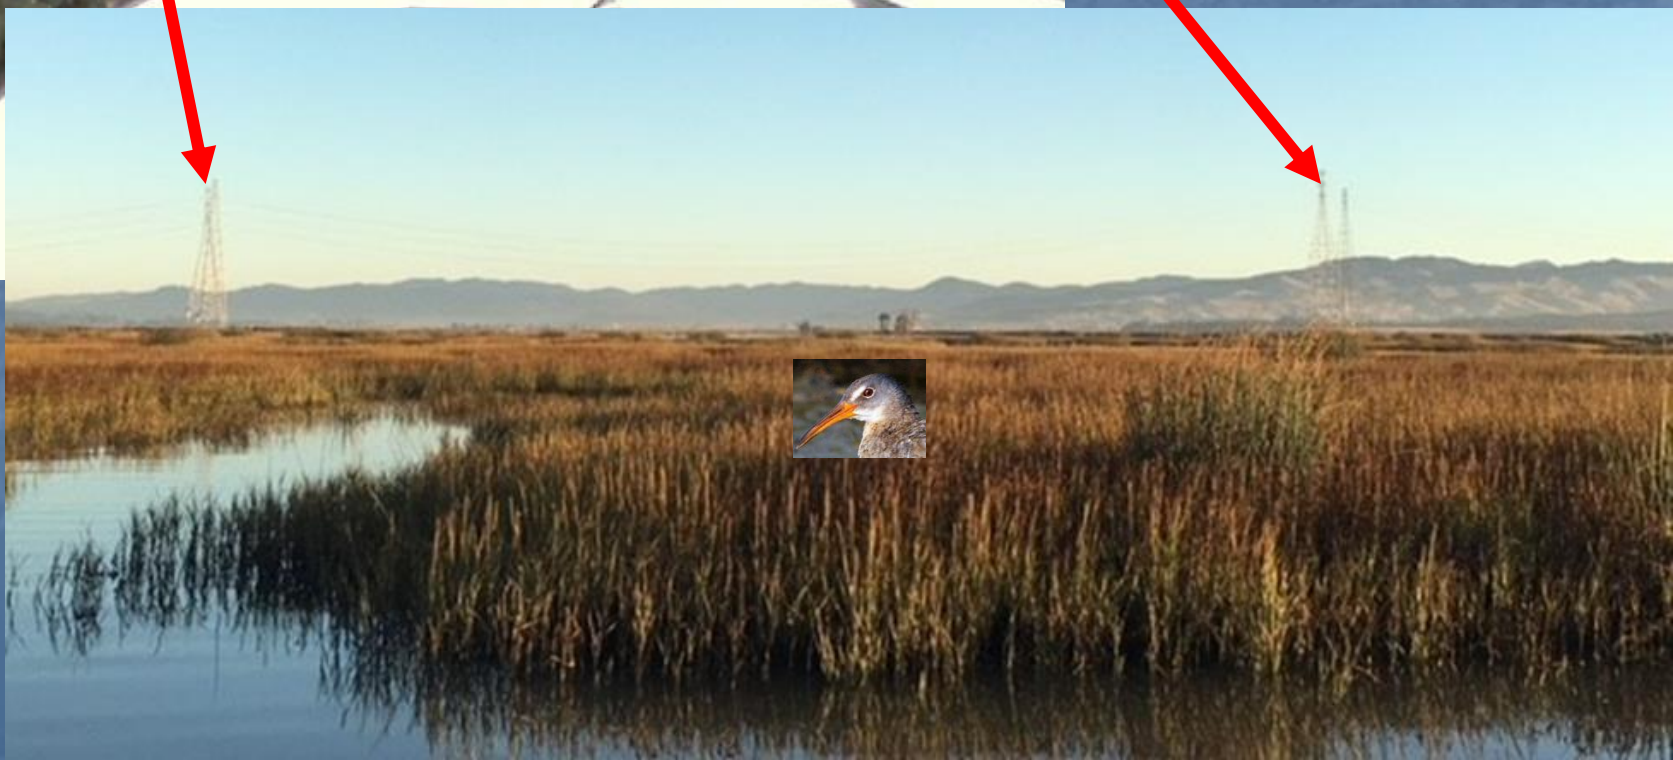
**Pond 4
2008**

2017

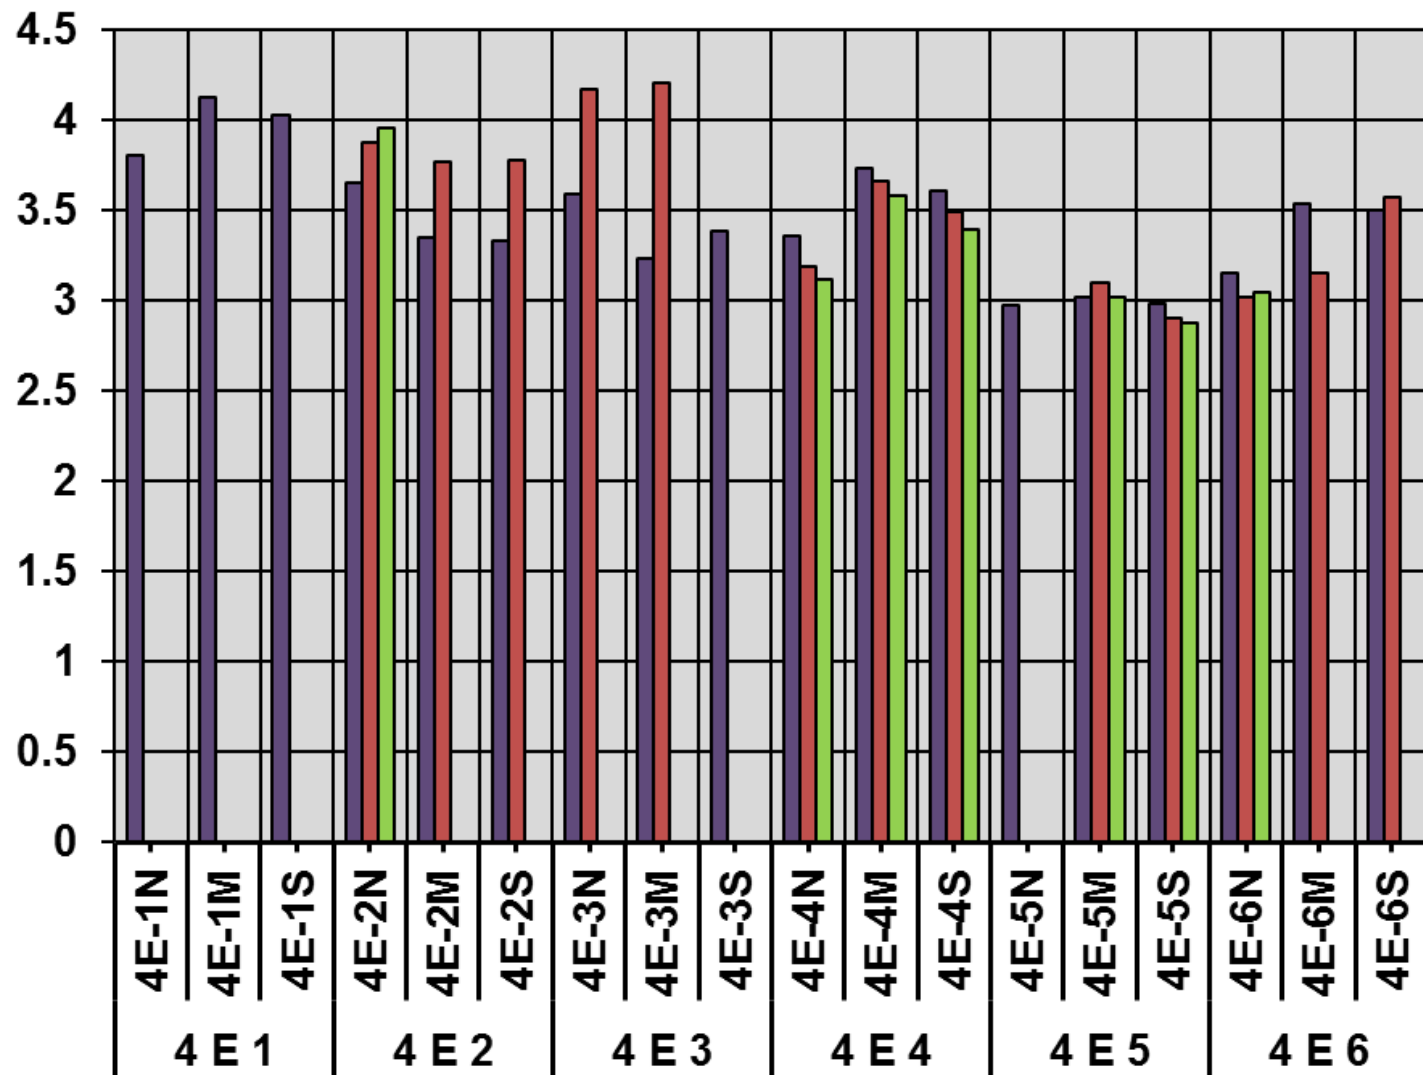
Pond 4

Feet

■ 2007 Measurement (ft) (Base) ■ 2013 Measurement (ft) ■ 2017 Measurement (ft)
